Spot Safety Project Evaluation

Spot Safety Project # 03-96-400

**Spot Safety Project Evaluation, of the Directional Crossover Installation, at the Intersection of
US 17 and Parkwood Drive-Western Shopping Plaza in Jacksonville, Onslow County**

Evaluation of Spot Safety Project Number 03-96-400 – The Intersection of US 17 and Parkwood Drive-Western Shopping Plaza, Jacksonville, Onslow County

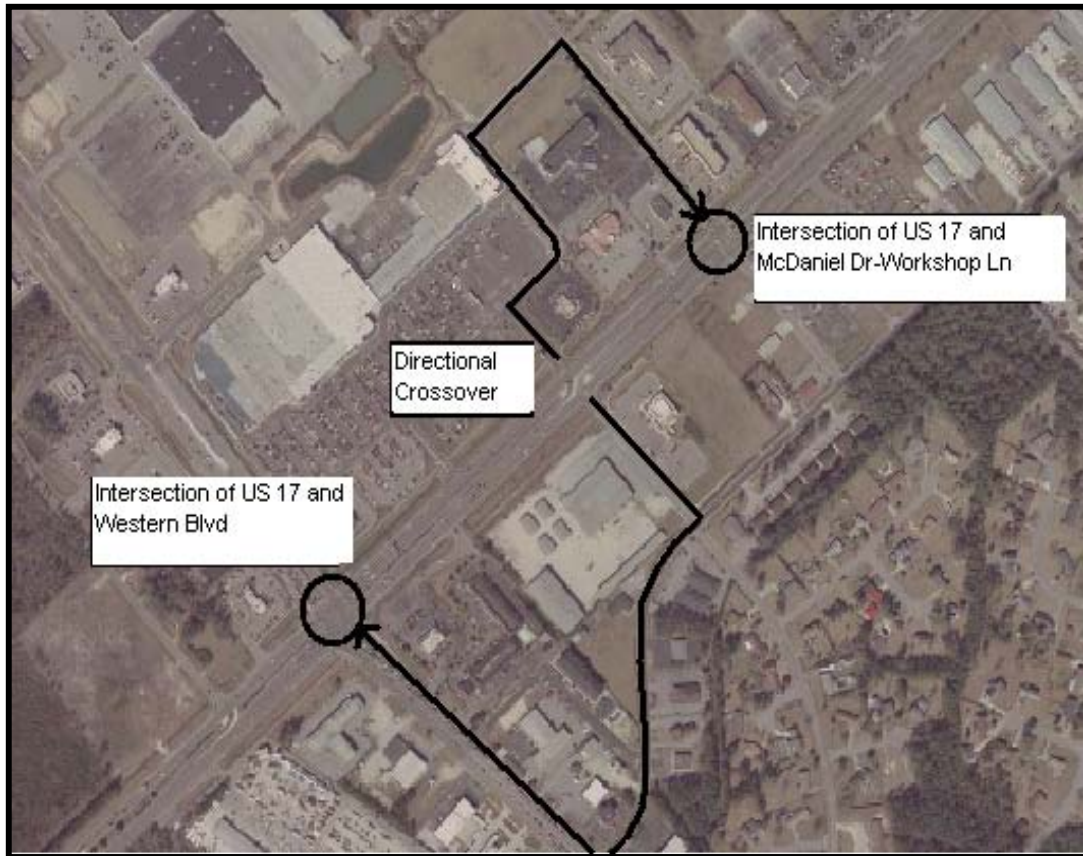
Aerial photograph of US 17 from SR 1470-Western Blvd to McDaniel Dr-Workshop Ln

Motorists that formerly turned left onto US 17 from Parkwood Drive or the Western Shopping Plaza via the crossover must now take alternate routes. Traffic may access US 17 from either McDaniel Drive-Workshop Lane to the north or SR 1470-Western Boulevard to the south. If U-turns are permitted at these signalized intersections, motorists may also perform this maneuver.

The naive before and after analysis of the signalized intersections on either side of the treatment location displays an increase in crashes. This increase in crashes may be attributed to the installation of the directional crossover at Treatment Intersection. The constructed raised islands in the crossover prevent through and left turn movements from the side streets. Therefore, motorists wishing to turn left from either Parkwood Drive or Western Shopping Plaza onto US 17 will need to access US 17 from the signalized intersection to the north or south. See the attached *Aerial Photograph* for a visual representation of the potential alternate routes.

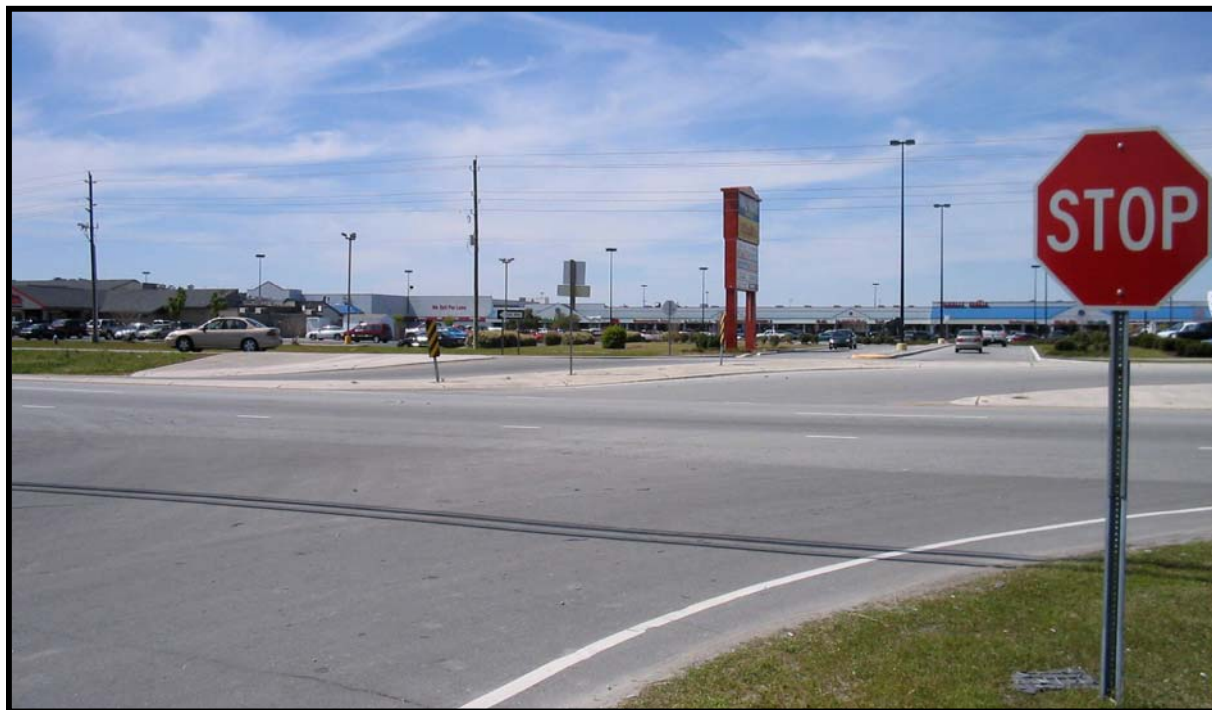
Looking west at the Directional Crossover from Parkwood Drive

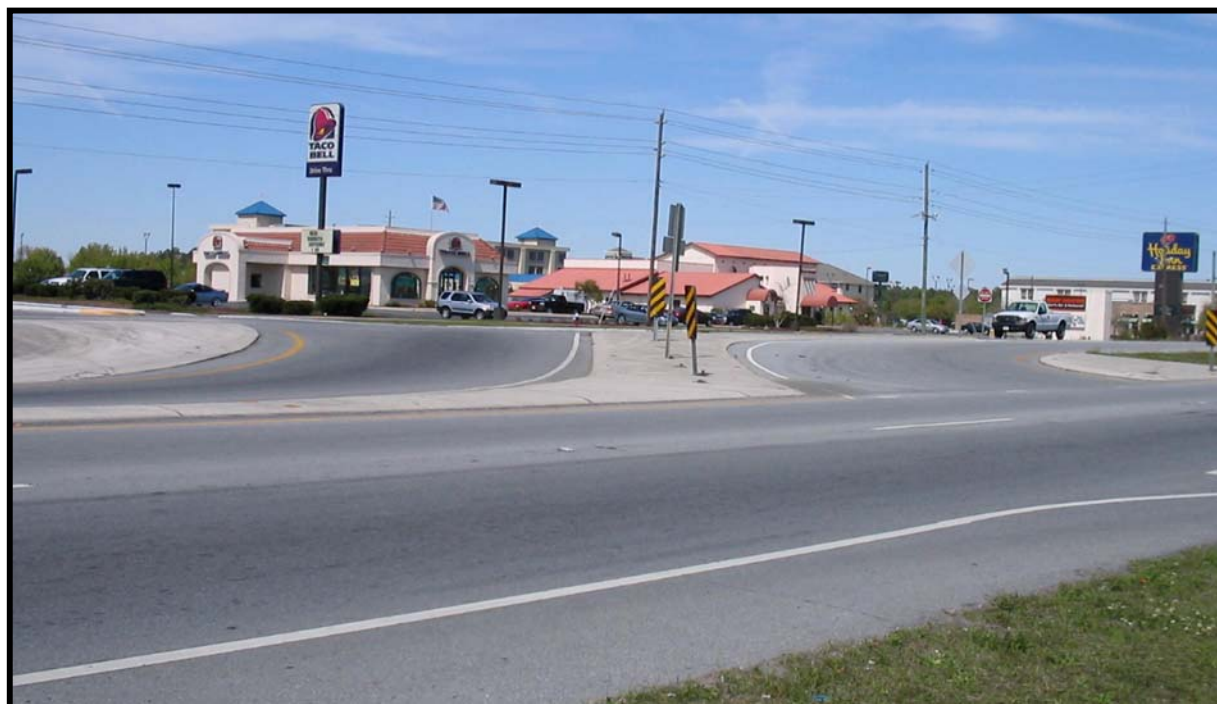
**Another view of the raised islands in the Directional Crossover
taken from just south of Parkwood Drive**
